Cimento Studio PTY LTD - Planocolour P 2K Microcement Coating 5mm

03 Mar 2024

This Report Is In Accordance with	AS 4586 : 2013 (New) - Appendix A
Testing carried out using the Wet Test Method and	Slider 96 (4S) Rubber slider
Date Tested:	03 Mar 2024
Test Report Number:	0303241
Client Name / Billing Address:	Cimento Studio PTY LTD - 56 / 6-14 Wells Road Oakleigh VIC
Property Tested / Nature and Purpose of Test :	56 / 6-14 Wells Road Oakleigh VIC / Certification Test
Surface Type - Colour, Size, Texture or Treatments:	Planocolour P 2K Microcement Coating 5mm

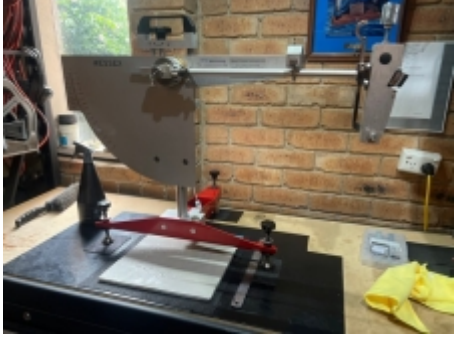
Location	Grade Degrees	Swing 1	Swing 2	Swing 3	Swing 4	Swing 5	* MEAN BPN *	SCV	Photo of Test Site
Specimen 1	Less than 1.5	30	30	29	28	28	28	N/A

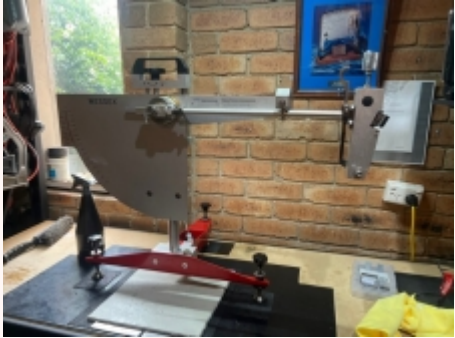
Specimen 2	Less than 1.5	35	35	34	35	34	34	N/A

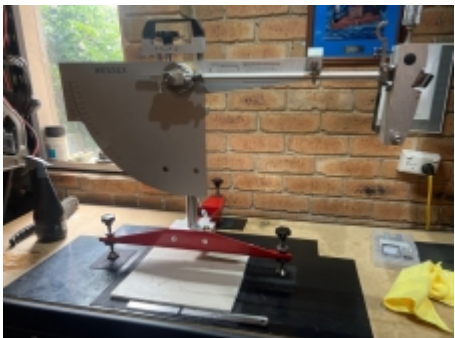
Specimen 3	Less than 1.5	37	37	37	38	38	38	N/A

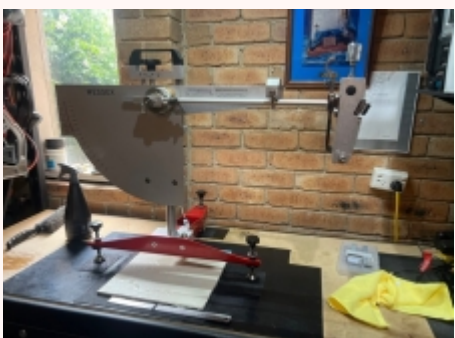
Specimen 4	Less than 1.5	39	39	39	38	38	38	N/A

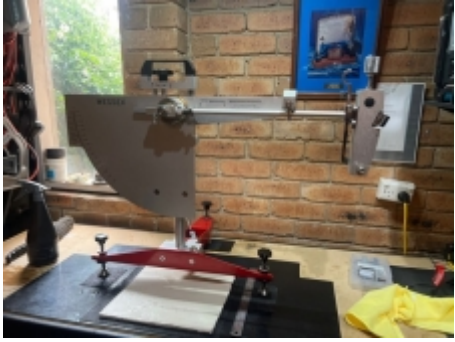
Location	Grade Degrees	Swing 1	Swing 2	Swing 3	Swing 4	Swing 5	* MEAN BPN *	SCV	Photo of Test Site
Specimen 5	Less than 1.5	40	40	40	39	39	39	N/A
